**Geotechnical Design Report
North Santa Monica Boulevard
Reconstruction
Beverly Hills, California**

November 27, 2013

51-1-10092-003

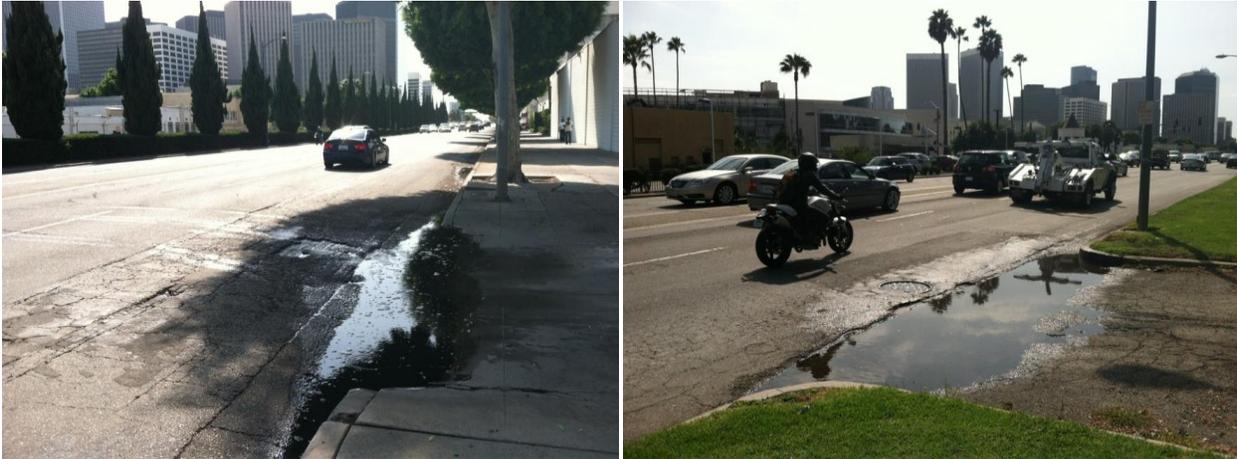
Storm drain inlets for drainage are located on north and south sides of the roadway. We observed two isolated areas of standing water during our site reconnaissance as shown in Photograph 1 below. One location is at the intersection of a driveway near Charleville Boulevard. The other location is at an alleyway intersection between North Linden Drive and Walden Drive. The water observed is not the result of inclement weather as there has not been any rain within the last day or two. Bus stops, composed of Portland concrete cement (PCC) pavement, are adjacent to drive lanes as shown in Photograph 2 below.

Photograph 1 – Ponding water adjacent to NSMB next to driveway (left) and alleyway (right)

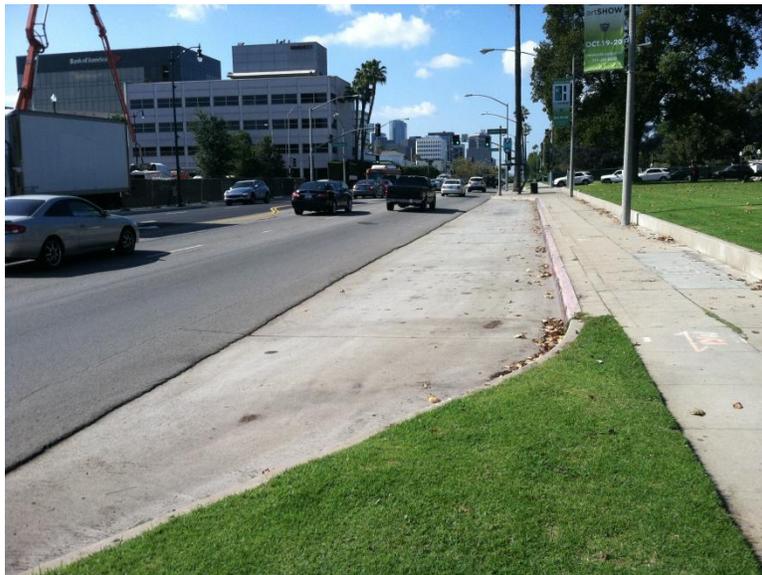
Photograph 2 – Typical PCC bus stop adjacent to NSMB

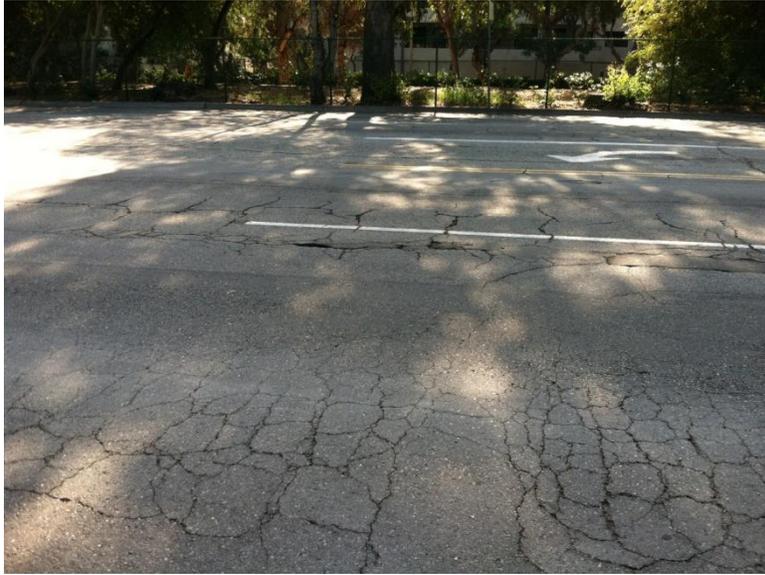
Asphalt concrete (AC) pavement along the drive lanes typically exhibited less distress than the pavement within intersections and 100 to 200 feet on either side of them. Moderate to severe alligator (fatigue) cracking and minor longitudinal, transverse, and reflective cracking was observed in the majority of drive lanes as shown in Photographs 3 through 5 below.

Photograph 3 – Example of severe alligator cracking along drive lanes

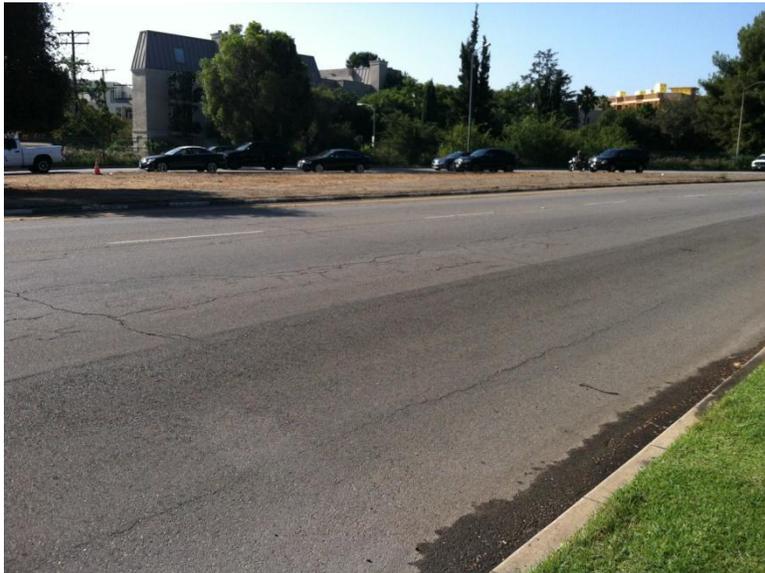
Photograph 4 – Example of longitudinal and transverse cracking along drive lanes

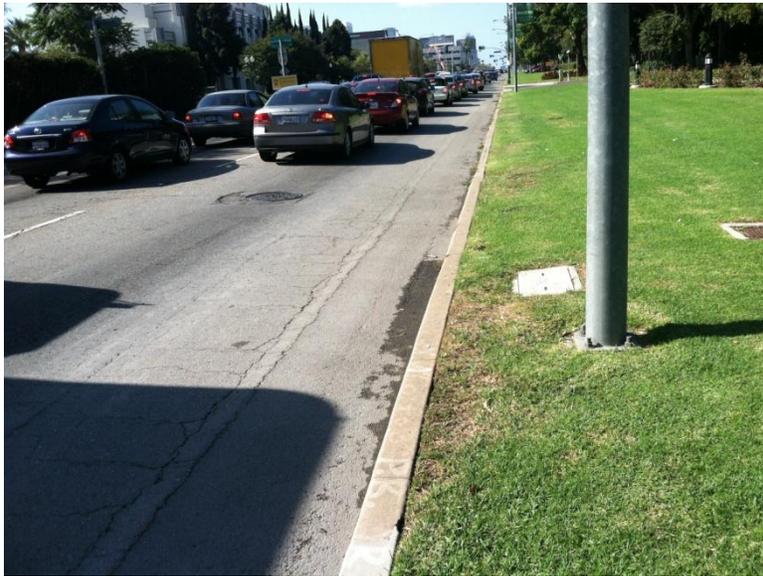
Photograph 5 – Reflective cracking of AC over concrete gutter

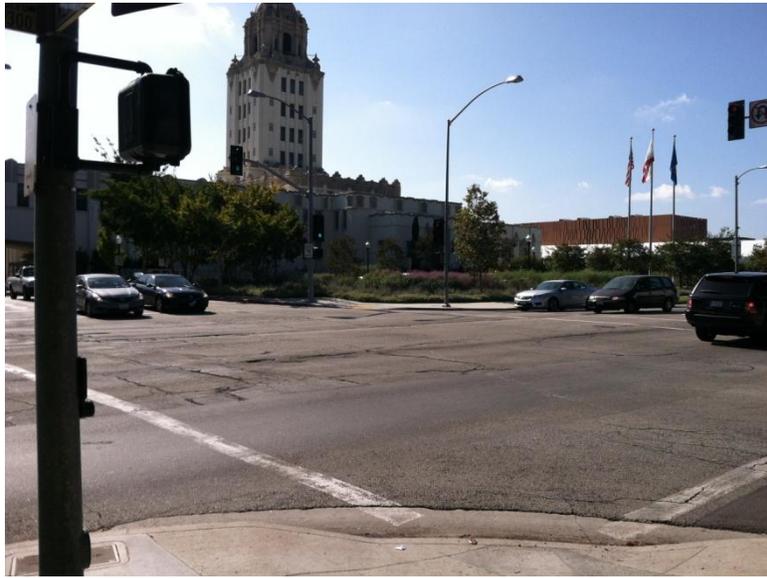
The AC pavement at or within intersections and 100 to 200 feet on either side of the intersections exhibited more distress than the drive lanes, likely due to braking and accelerating vehicles. Larger, busier intersections often showed moderate to severe evidence of patching along utility trenches and potholes, while smaller and less trafficked intersections typically showed less distress. The majority of drive lanes leading up to intersections were severely distressed and showed signs of cracking, deformation, and deterioration. This included corrugation, one to four inches of rutting, potholes (maximum observed was 12 inches in diameter), severe alligator cracking, and slippage cracking as shown in Photographs 6 and 7 below.

Photograph 6 – Severe patching at the intersection of North Rexford Drive and NSMB

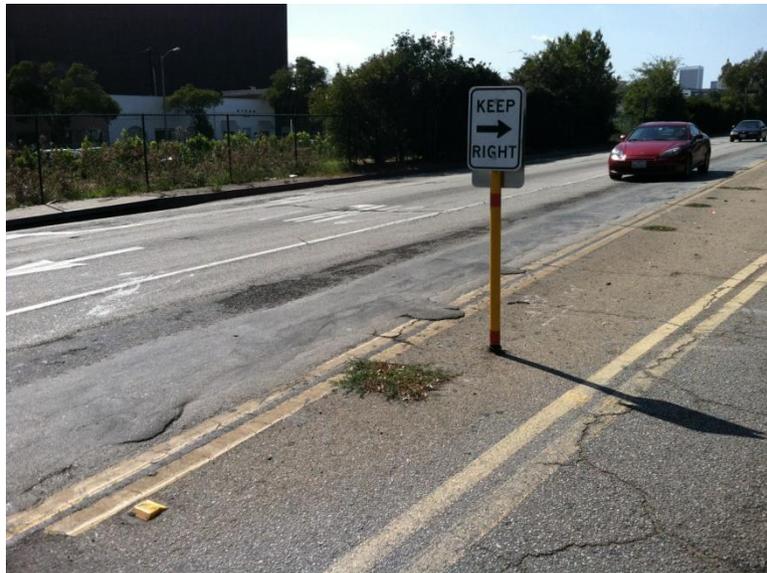
Photograph 7 – Severe deformation and deterioration of drive lanes leading up to the intersection of Beverly Boulevard and NSMB
